OUTLET CREEK DAM HEIGHT ANALYSIS – Summer 2024

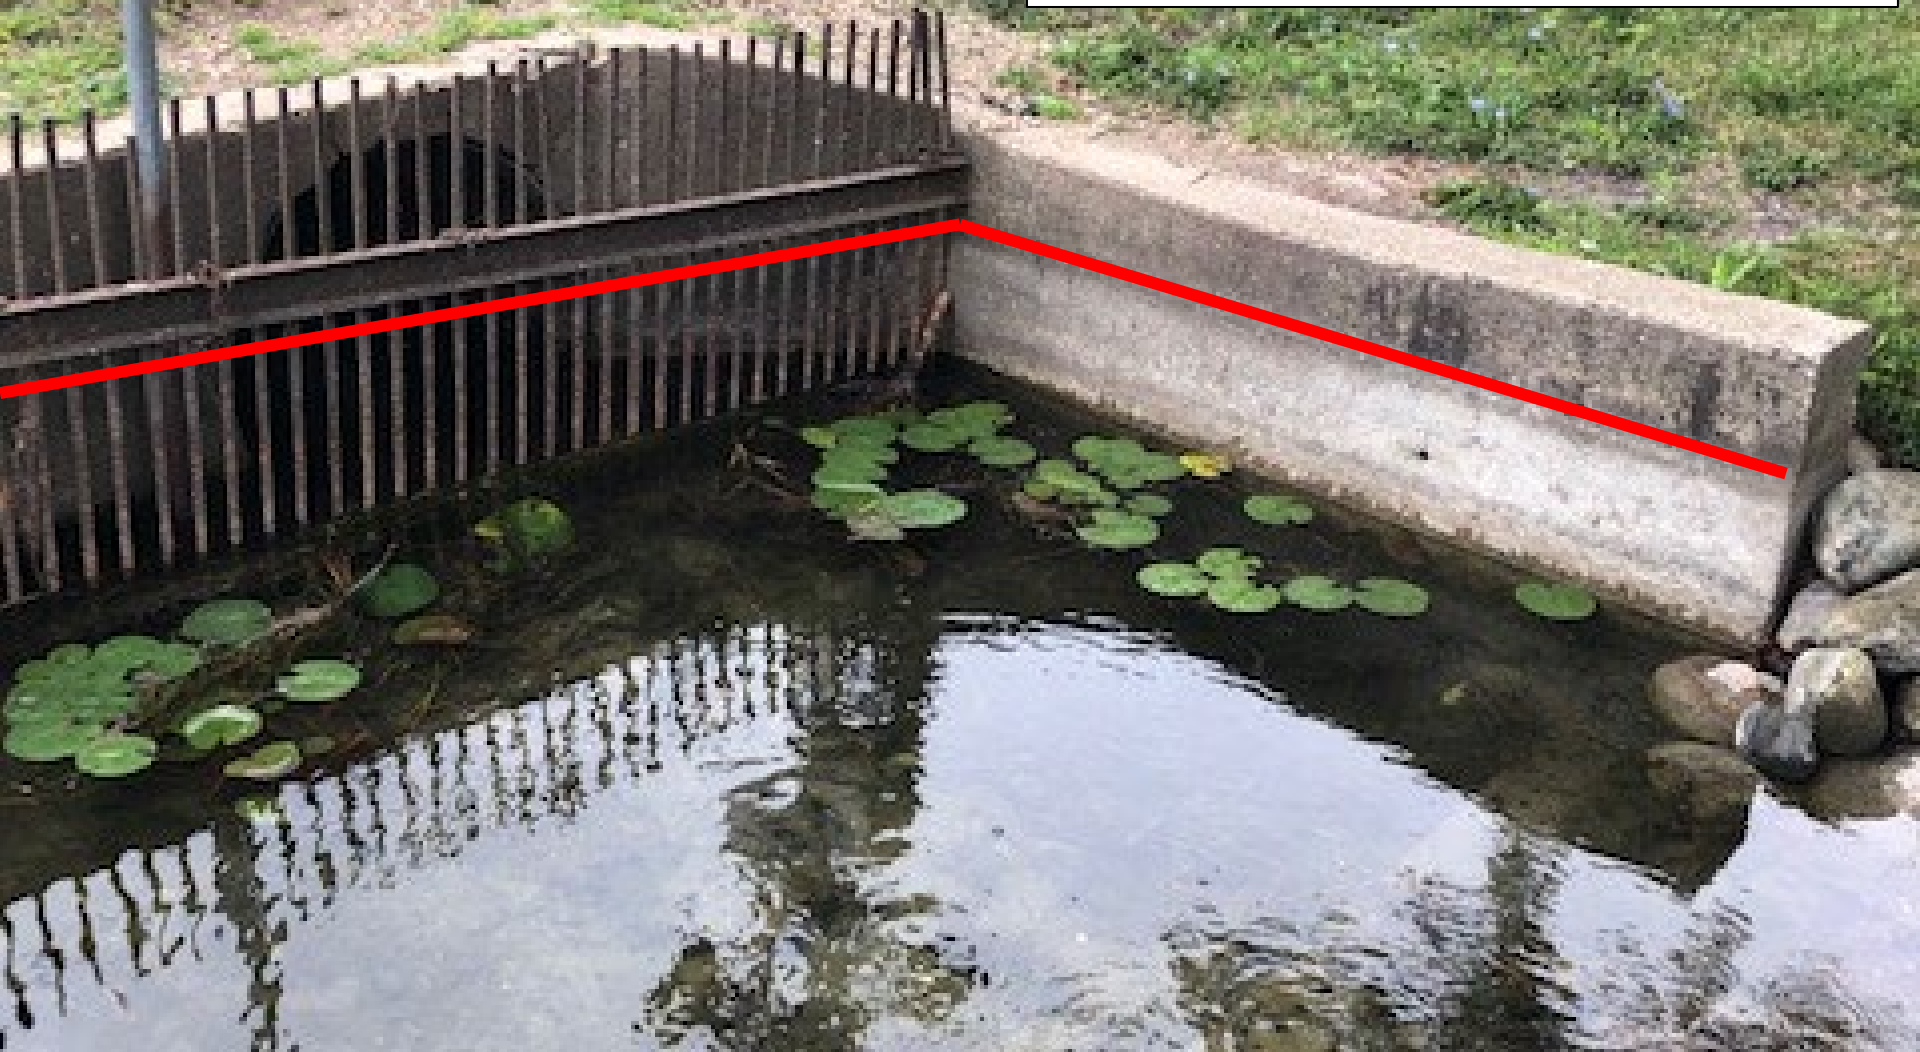
- The level authorized by the WPSC is approximate because there are no physical benchmarks.
 - The top of the dam has been determined to be about 6” below the stained concrete.

- The conclusion of the field study shows that the current top of the dam is below the “summer elevation” and could conceivably be raised maybe 4 to 6 inches.

1944 WPSC "Summer Elevation"
~6-1/2" Below Top of I-Beam
Approx. at Bottom of Concrete Stain

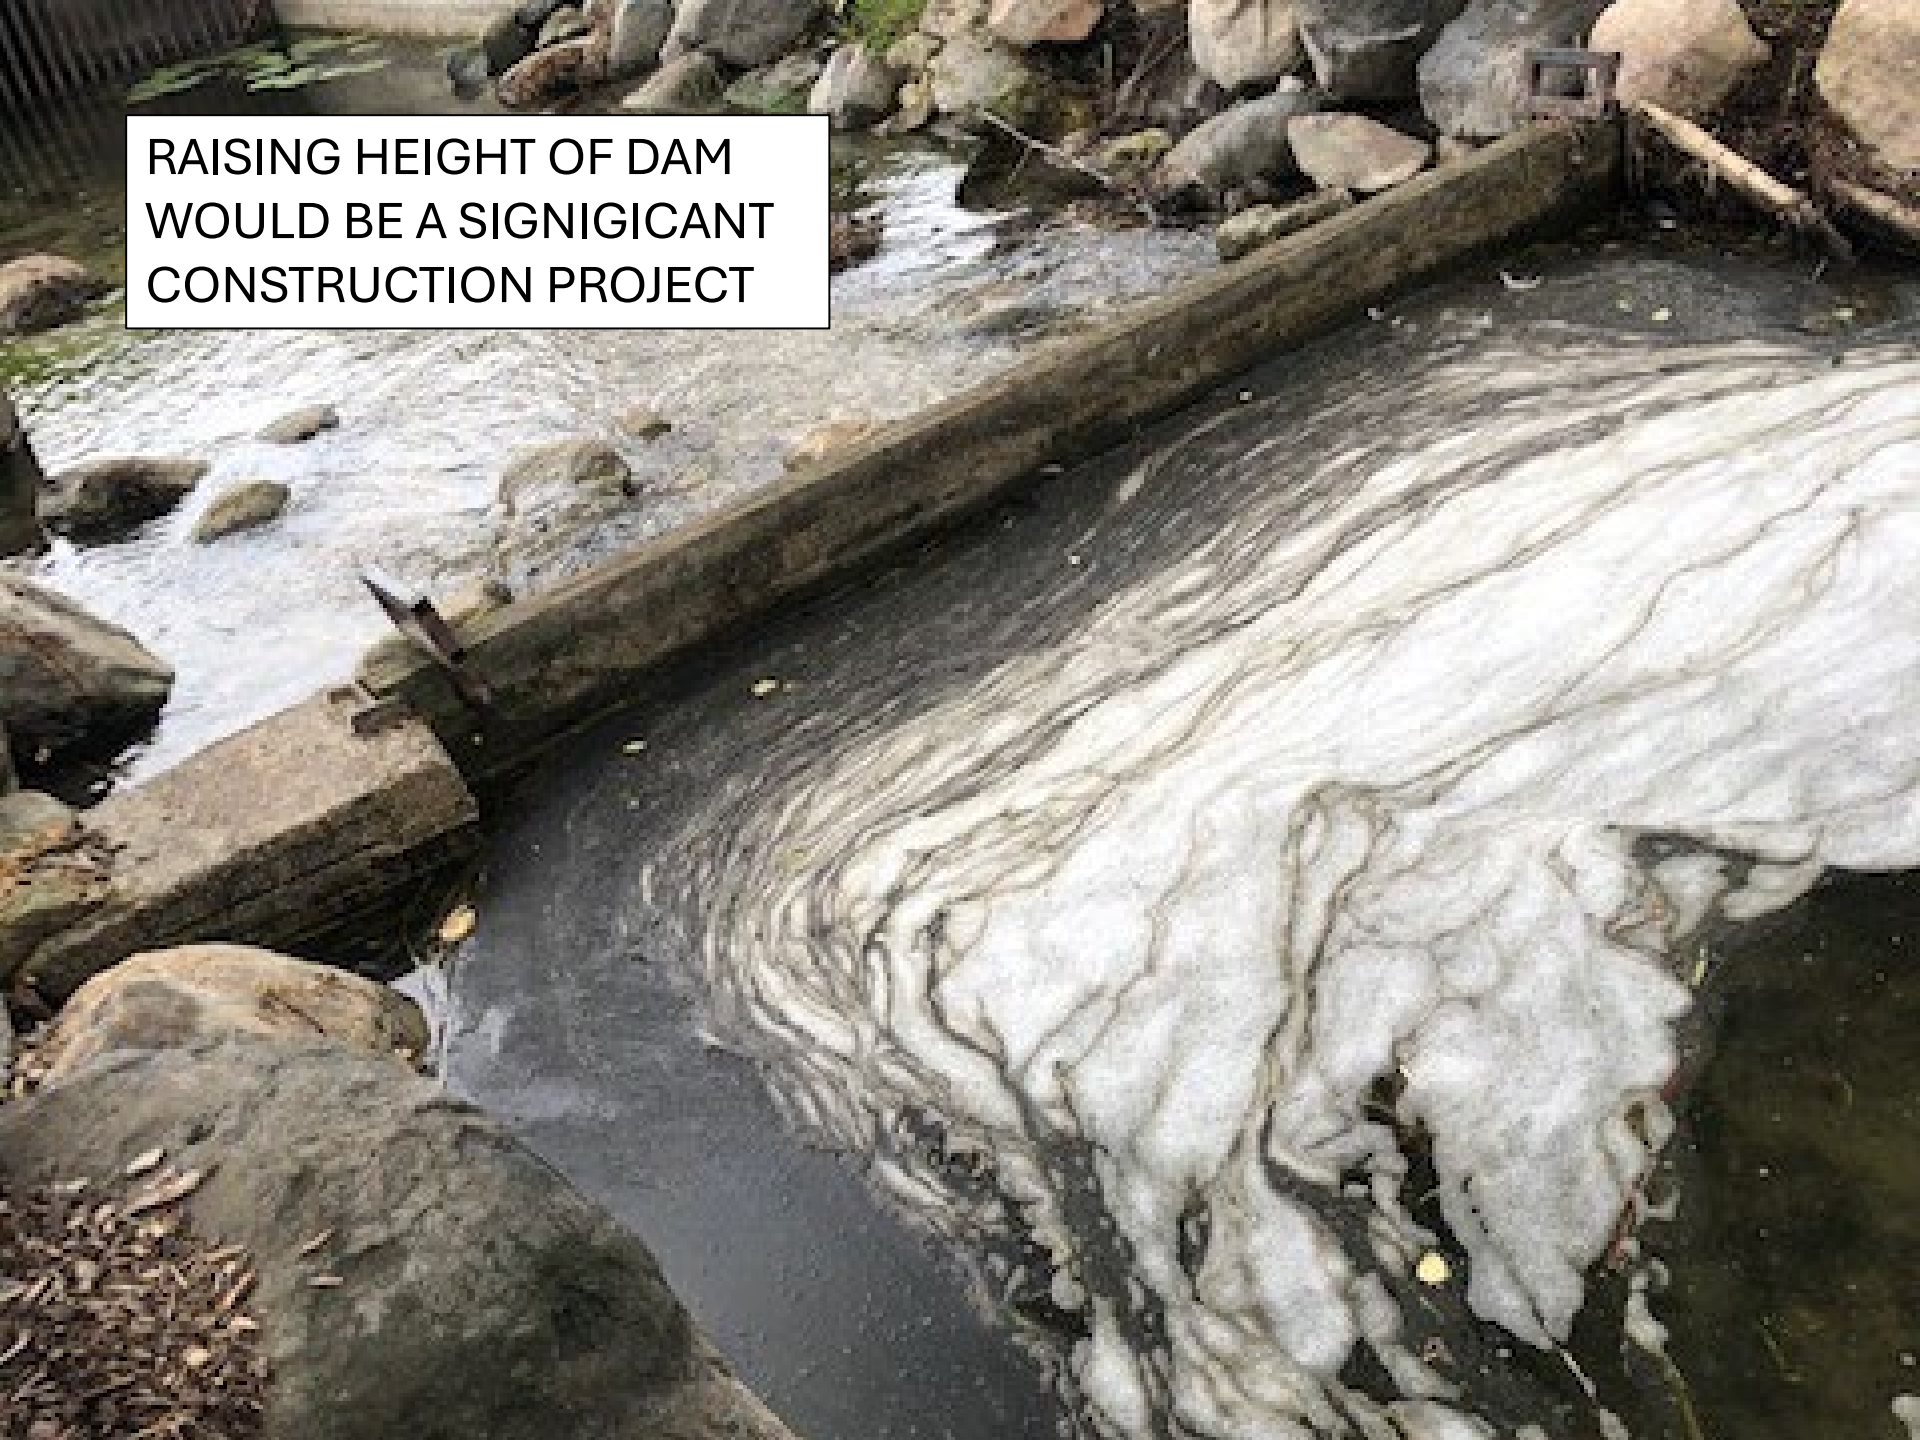
Top of Dam

CAN TOP OF DAM
HEIGHT BE RAISED?
MAYBE 4" to 6"?

RAISING HEIGHT OF DAM
WOULD BE A SIGNIFICANT
CONSTRUCTION PROJECT

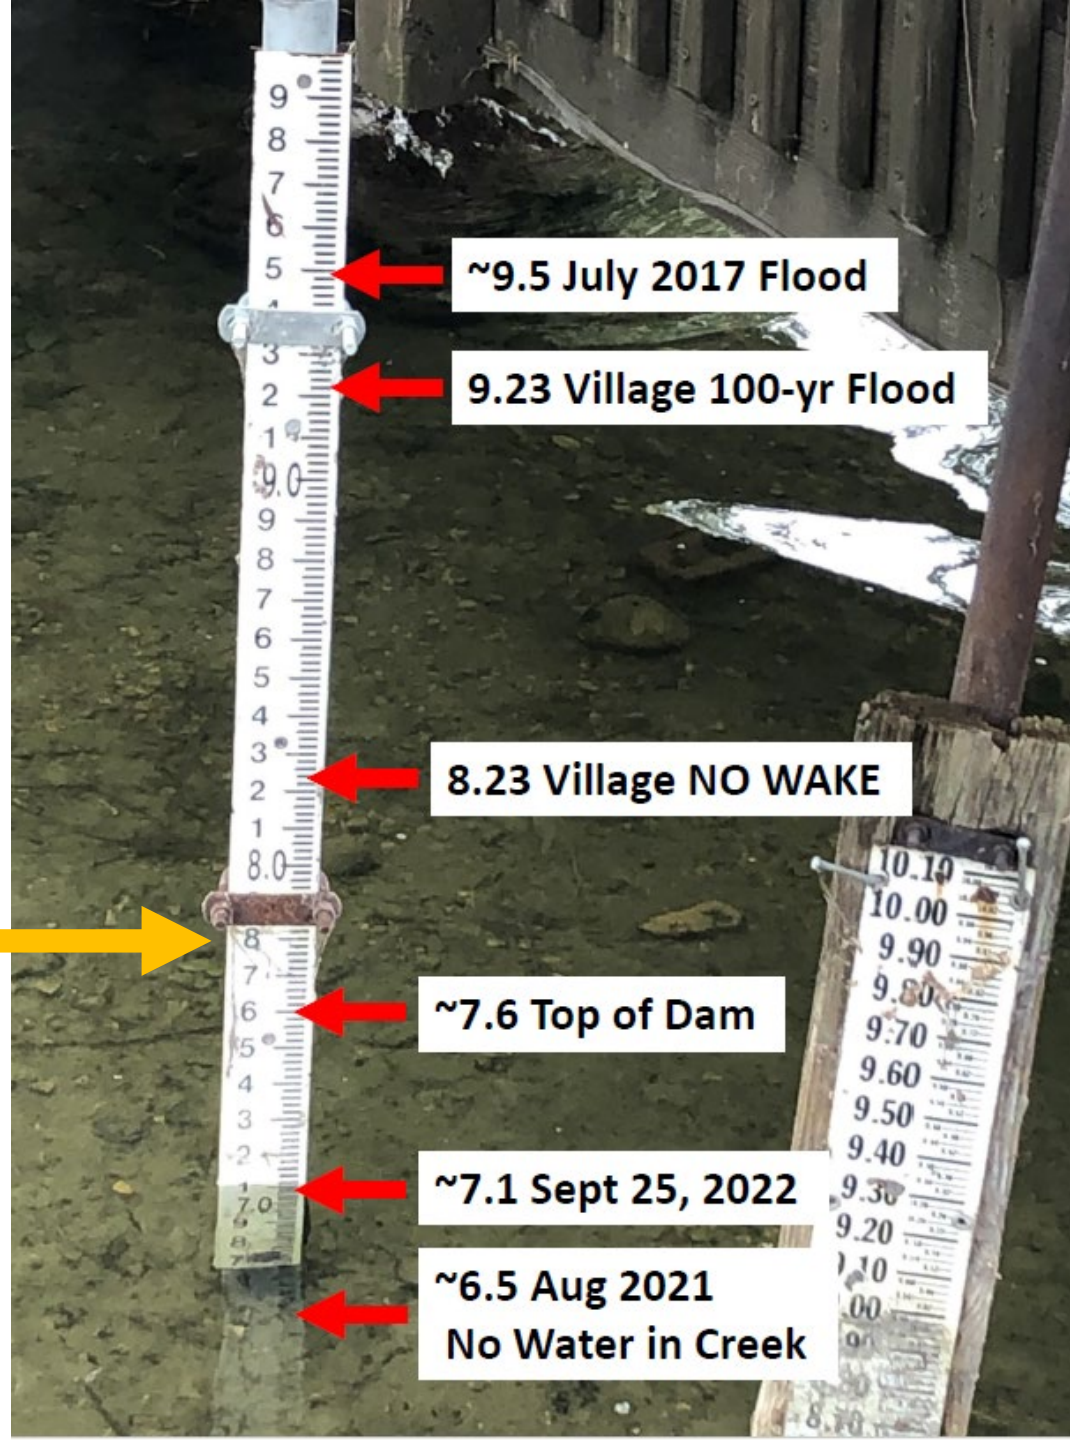
If Top of Dam
Increased 4"
To ~7.93
