Lake & Pond Resource LLC

Silver Lake 2020 Aquatic Plant Survey Report

Prepared for:
Silver Lake Protection Association

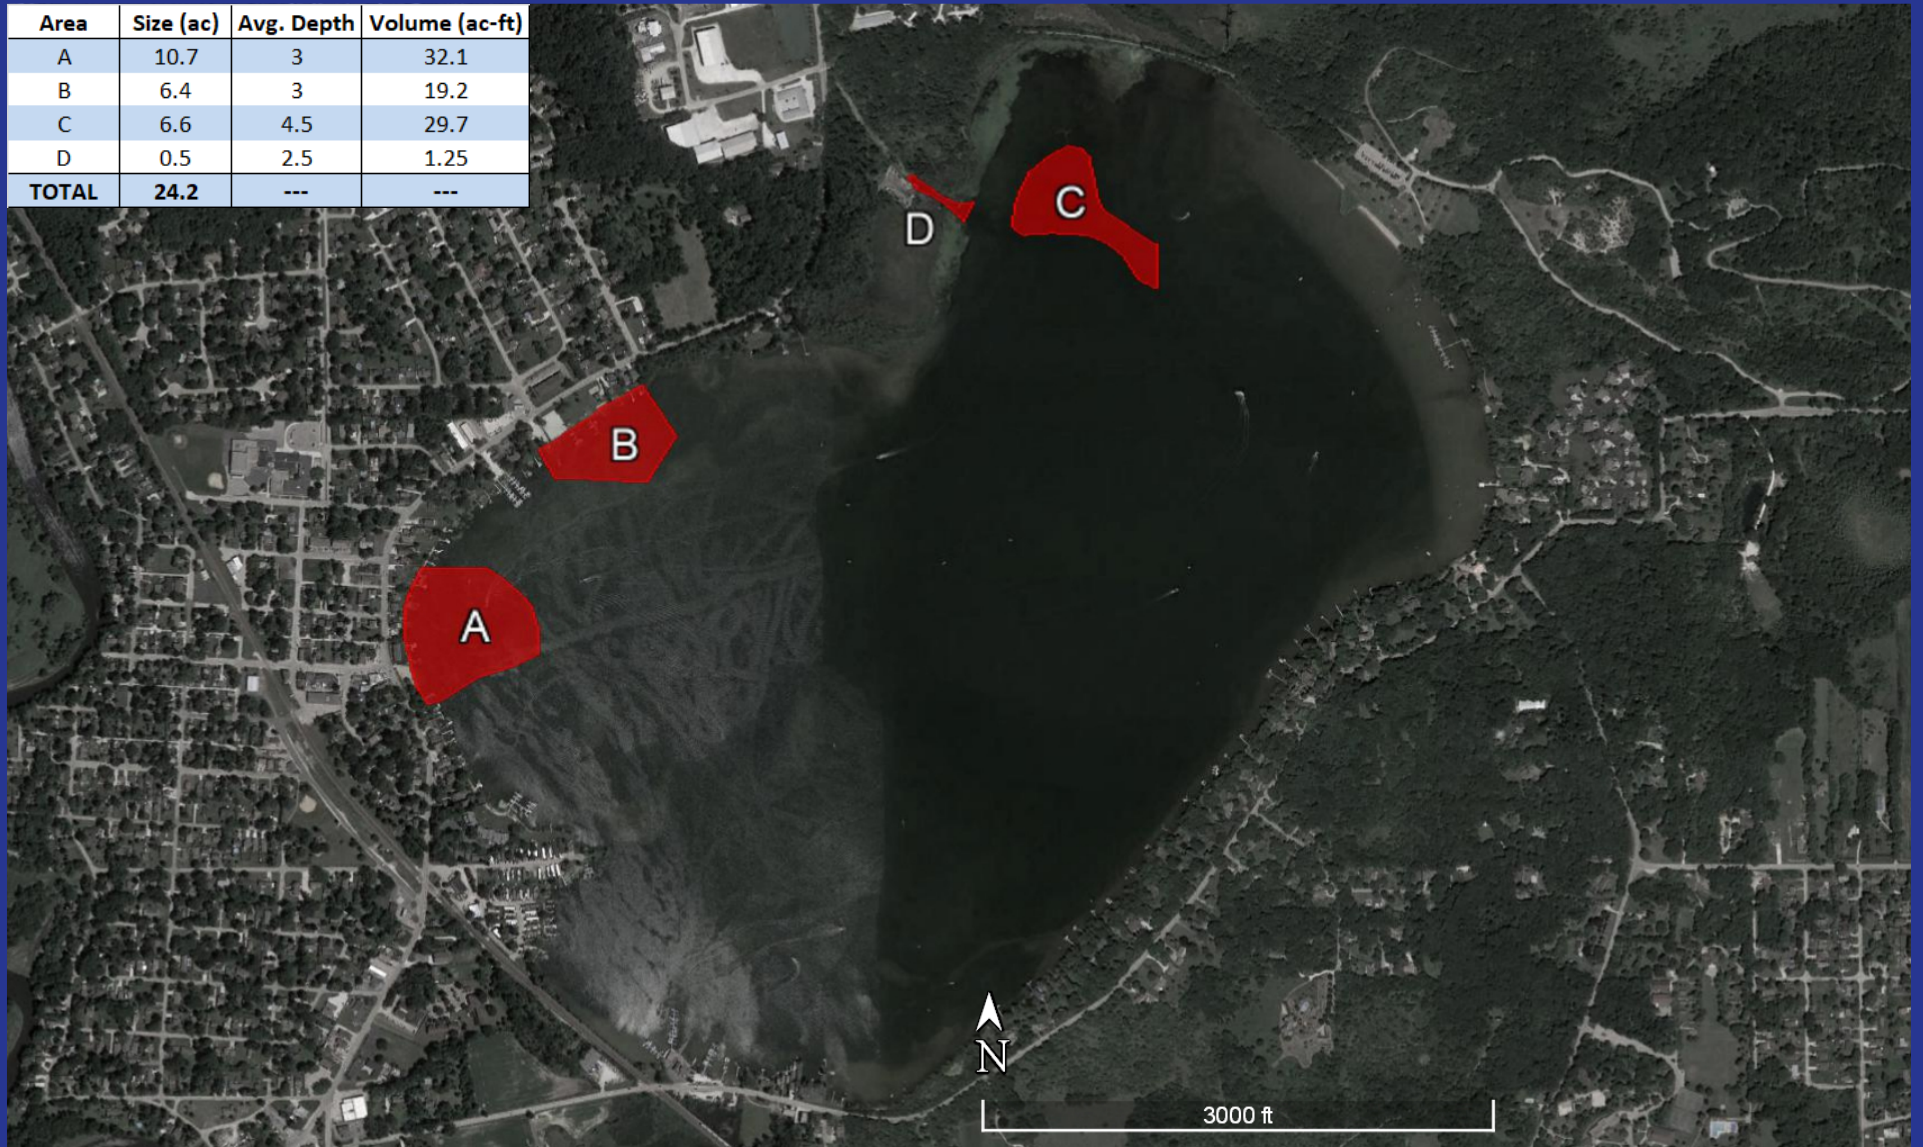
Therefore, we recommend management in 2021 that focuses on reducing areas of the densest areas of HWM growth (Figure 3) with a highly targeted approach using ProcellaCOR EC to reduce impacts to non-target species. Any control should be coupled with continued monitoring and planning for 2022. For 2021 management, we recommend the following course of action:

Area	Size (ac)	Avg. Depth	Volume (ac-ft)
A	10.7	3	32.1
B	6.4	3	19.2
C	6.6	4.5	29.7
D	0.5	2.5	1.25
TOTAL	24.2	---	---

- **February 2021:** Apply for WDNR permit for up to 24.2 acres for control of HWM (Figure 3).
- **May/June 2021:** Herbicide application for E/HWM control using ProcellaCOR EC. Rates are to be determined based on further discussion with the product manufacturer.
- **August/September 2021:** aquatic plant survey and mapping assess the HWM population
- **October/November 2021:** Complete an assessment of HWM present for 2021 planning
 - Update and submit management report and recommendations to the Association. Future planning may involve any of the following actions:
 - Varying scale of HWM control in 2022
 - WDNR AIS Grant application to assist in 2022 funding
 - Continued monitoring
